X-RAY TUBE ARCING : MANIFESTATION AND DETECTION DURING QUALITY CONTROL

S. Tabakov^{1,2}

¹ Dept. Medical Eng. and Physics, King's College London, SE5 9RS, UK; ² President IOMP, York YO24 1ES, UK

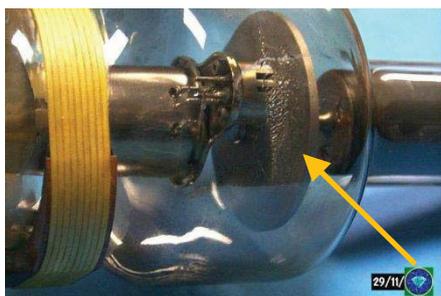
The arcing inside old X-ray tubes is more powerful and more dangerous. It is most often observed in X-ray tubes with glass envelope, but can also be present in metal X-ray tubes. During each exposure the glass envelope is heated to very high temperature (due to the close proximity of the glass to the glowing-hot Anode - only several centimeters). This is followed by cooling to less than 100°C temperature, and new heating during the next exposure, thus leading to thermal stress of the material, what causes microcracks in the glass after several years of work (depending on the power and frequency of exposures). This process increases the release of ions inside the tube. Additionally the evaporation of the Cathode filament and the Anode during the exposures leads to metallization of the glass, what further creates conditions for arcing inside the X-ray tube Fig.1 shows an old X-ray tube (after decommissioning) with many cracks on the glass surface.

Fig.1 Decommissioned X-ray tube with severely cracked glass envelope (at the side opposite the cathode and anode).

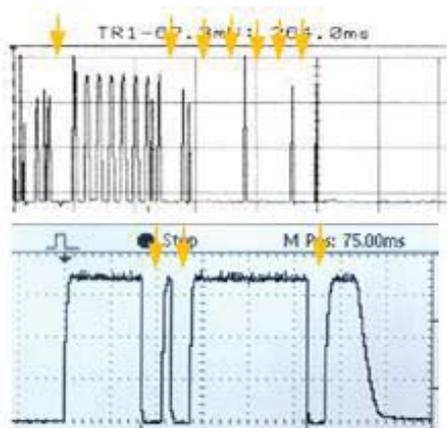
Fig.3 kVp oscillograms of X-ray tubes during arcing (see arrows)
 -Above: arcing of tube with classical X-ray Generator - some kVp pulses are missing in clusters, as arcing is associated with these (the uneven kVp amplitudes are another sign of micro sparks).
 -Below: arcing of tube with medium-frequency X-ray Generator -note the sharp drops (short-circuit) of the kVp line at 3 instances.
 In both cases the arcing has been followed by self-recovery of the vacuum inside the X-ray tube (kVp recovers to its pre-arc value).

Anode is in fact a short-circuit, what causes a sudden drop of kVp (Fig.3). During this detection, it has to be insured that the kVp meter has sufficient bandwidth (see Annex). This is of special importance when assessing medium-frequency Generators. In case the kVp meter is not fast enough some sudden decreases in kV can remain undetected due to missed signal registration. This detection is a proof of the importance to use an oscilloscope and kVp meter with oscilloscope output for assessment of equipment performance during QC tests

Detection of arcing is very important, as its presence is an immediate sign for the urgent need of X-ray tube decommissioning and replacement. Otherwise artefacts and related repeat of exposures are imminent, and importantly, equipment damage is very likely to occur. There are two methods to assess arcing - Direct (Fig.3) and Indicative.

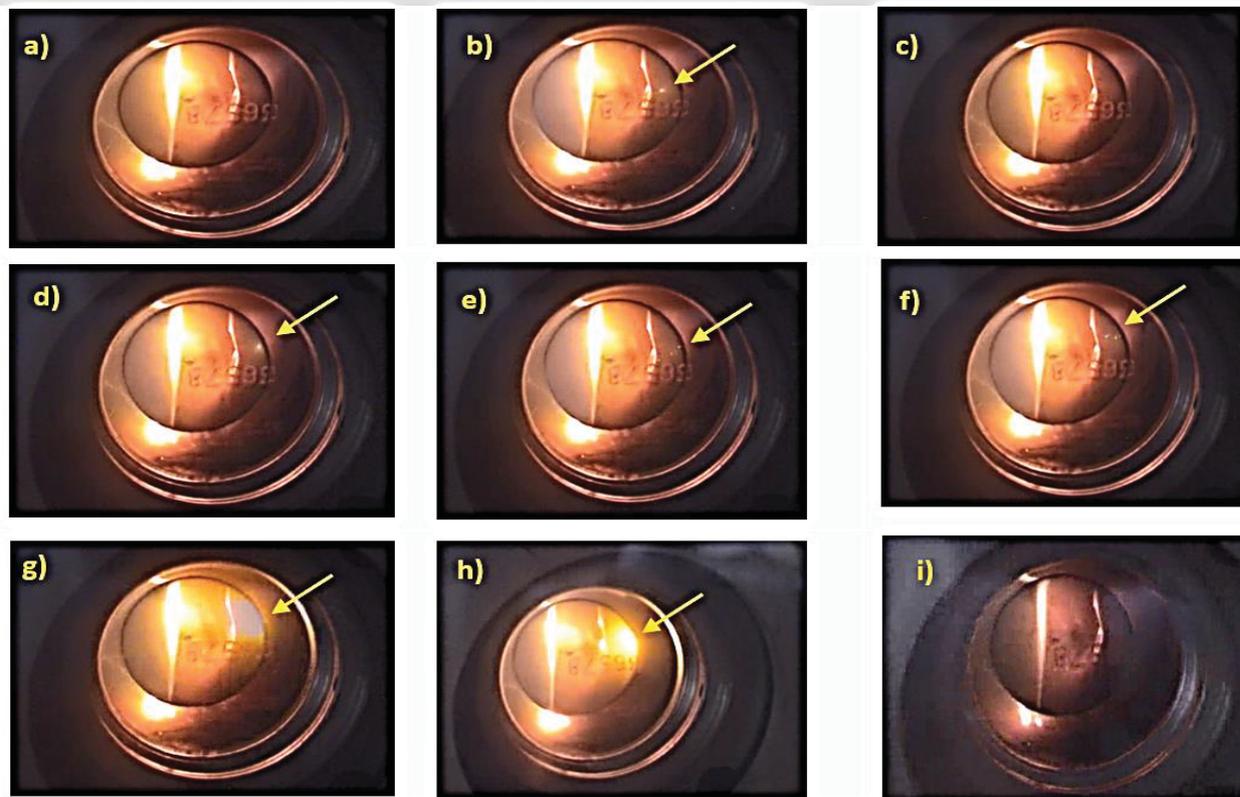
Fig.2a shows the normal work of the Anode (left, glowing hot) and the Cathode (right, only the profile of the

filament is seen inside the Cathode cup). In front of these is the glass envelope (with a serial number). Fig.2b shows a small spark close to the Cathode (in the form of a bright dot marked with arrow), while Fig.2c shows the restored normal work of the X-ray tube immediately after the brief spark. These events are of the order of microseconds and only the after-glow of the discharge is recorded (in fact integrated) by the slow video recorder (one video frame lasts tens of msec).

Fig.2d shows another similar brief spark (at a different spot near the Cathode); this is immediately followed by a cluster of 3 small sparks in this area, seen on Fig.2e. Each of these events is usually associated with a very quick flash of light inside the X-ray tube. After these small sparks the vacuum could be restored (what is often the case), but also there is a high probability that the phenomenon could continue with increased strength and further clusters of sparks may appear - see Fig.2f. This produces a very bright flash of light inside the X-ray tube, associated with a strong “cracking noise” (sometimes even a noticeable “boom”). This creates significant mechanical stress inside the X-ray tube, what may further crack the glass and in turn - increase the ionization. This positive feedback creates further large cluster (a ball) of sparks - Fig.2g. This leads to the creation of a very strong arc inside the X-ray tube - Fig.2h. At this time the X-ray tube produces a burst of bright light associated with a loud sound (strong arcing, which could even lead to implosion of the tube). During this arc a very strong current passes through the tube electrodes, and further through the Rectifier and the HV Transformer of the X-ray Generator, what in turns activates the electrical safety circuit. This circuit senses the unusually strong I_a (and/or sudden decrease of the kV due to the short-circuit inside the X-ray tube). The safety circuit switches-off the High Voltage (HV) - see Fig.2i, which shows only the remaining after-glow of the cooling-down Anode. After a quick spark the system may restore the work of the Generator during the exposure, but the high current could also turn off the fuse of the equipment. If the sparking event is very fast and strong, and the safety circuit cannot react, it can damage both the X-ray tube and more importantly - the X-ray Generator.

Fig.2 (a-i) Arcing - sequence of sparks inside an old X-ray tube with rotating Anode: a frame-by-frame analysis of a 2 minutes video through an open X-ray tube housing (the explanation of the images is inside the text of the paper); the filming of the video is described in the Acknowledgements

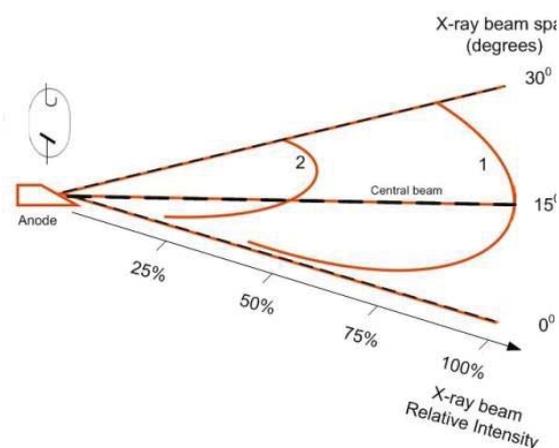
Measuring the increased Heel effect, associated with the ageing of the X-ray tube is another indirect way to roughly estimate the time of expected X-ray tube arcing, hence tube replacement. Figure 4 shows the shifting of the maximum of the X-ray beam intensity from the central beam (15°) toward the Cathode. This leads to further decrease of the already smaller beam intensity at the side of the Anode – i.e. more prominent Heel effect. The latter can be directly measured from a sufficiently long radiogram of a test object placed in parallel to the Anode-Cathode axis – Figure 5. However this will also require having the initial measurements of the Heel effect of a new X-ray tube, what is very rarely made. This method is even less accurate, as the Heel effect varies with different types of X-ray tubes and equipment.

Fig.4 X-ray tube intensity spatial distribution for new X-ray tube (curve 1) and an old one (curve 2). The X-ray intensity is shown in relation to the maximum intensity (100%) at the middle of the central beam of a new X-ray tube. Note also the shifting of the maximum of the intensity from the central beam (15°), what leads to significant decrease of the beam intensity at the side of the Anode – i.e. increased Heel effect.

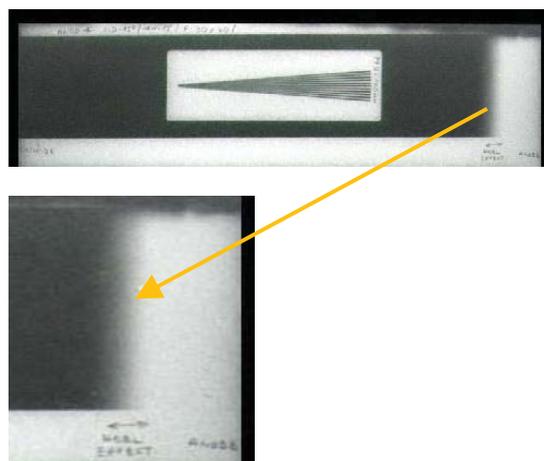
Fig.5 Illustration of Heel effect in old X-ray tube (gradual drop of optical density at the right side of radiograph). Note the zoom of the Heel effect zone (below), which is usually about 2-5 mm wide on the radiograph recording the effect.

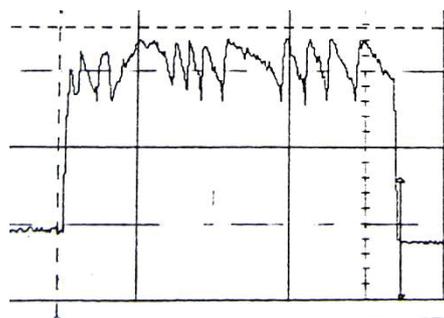
The assessment of medium frequency X-ray Generators (as well as arcing) requires kVp meters, whose electronics is able to detect quick events. Some old kVp meters were based on low-cost electronic components with insufficient bandwidth. Due to this reason kVp waveforms and fast events were incorrectly presented (Fig.7). Soon after the introduction of the medium frequency Generators the author discussed the problem about misregistration of fast kVp changes with a leading manufacturer. This led to correction of the measuring equipment, but some of the old kVp meters are still available (as second hand equipment). Due to this reason the suitability of the measuring equipment should be checked before using it for arcing detection. Obviously kVp meters without an output for oscilloscope are not suitable for such detection.

Fig.7 kVp waveform of a medium frequency Generator made with kVp meter with insufficient bandwidth. Note on the oscillogram the uneven kVp pulses due to lack of registration of the high frequency signals. Such kVp meter can miss (or present a false appearance) of the fast arcing events.
