X-RAY TUBE ARCING : MANIFESTATION AND DETECTION DURING QUALITY CONTROL

S. Tabakov^{1,2}

¹ Dept. Medical Eng. and Physics, King's College London, SE5 9RS, UK; ² President IOMP, York YO24 1ES, UK

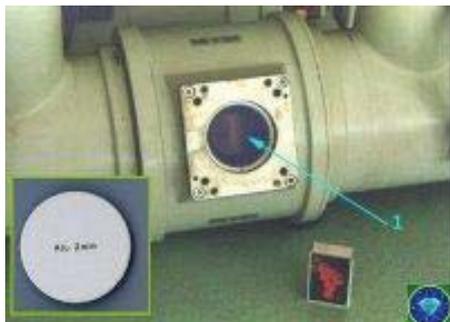
tube. The video clip has been made with a small video camera directly attached in front of the radiolucent window of the X-ray tube – Fig.6. Before showing signs of arcing, the filmed X-ray tube has been intensively used for about 7 years, as part of an Digital Angiographic Equipment. The video has been shot during high-dose fluoroscopy mode. Immediately after this the tube has been replaced.

Fig.6 Outside view of an X-ray tube housing. The LBD and the inherent X-ray tube filtration have been removed (Al filtration plate is shown in the left segment of the image). Note that through 1 (the radiolucent window) the cathode and the anode disk can be observed (as in Fig.2), taking all radiation safety measures.
